# Shoreline Change Analysis 1980-2020

Dillingham, Alaska

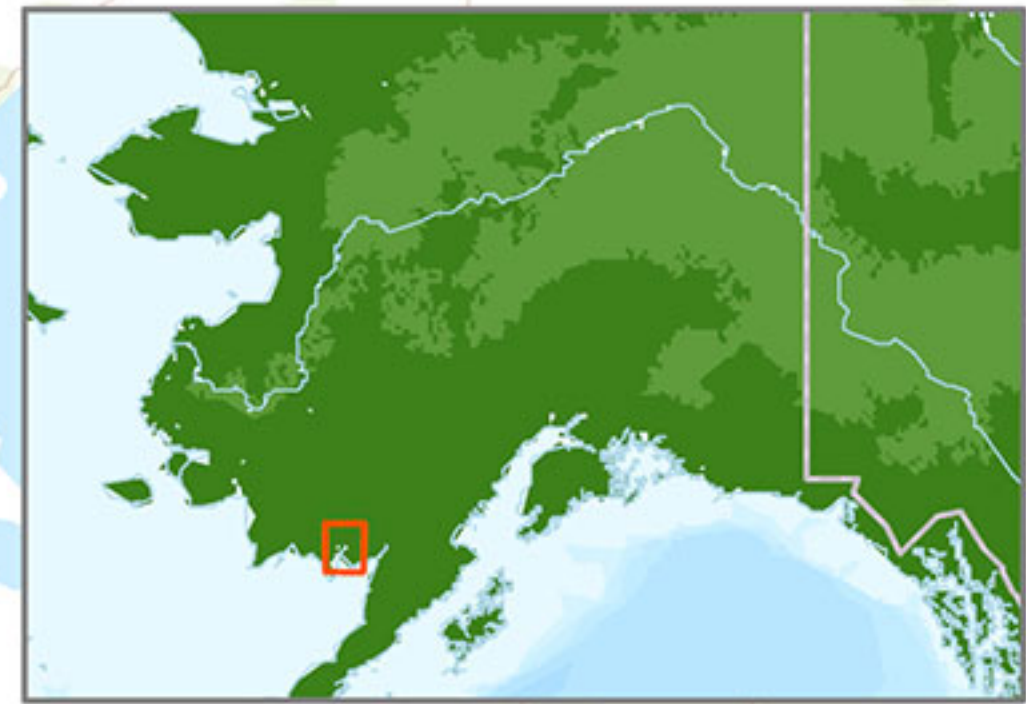
## Erosion Rate by WLR\*

Scale: 1:42,000
